Cypress Creek Project Watershed Characterization Report

CYPRESS CREEK WATERSHED PROTECTION PLAN

Characterization Report

December 18, 2010

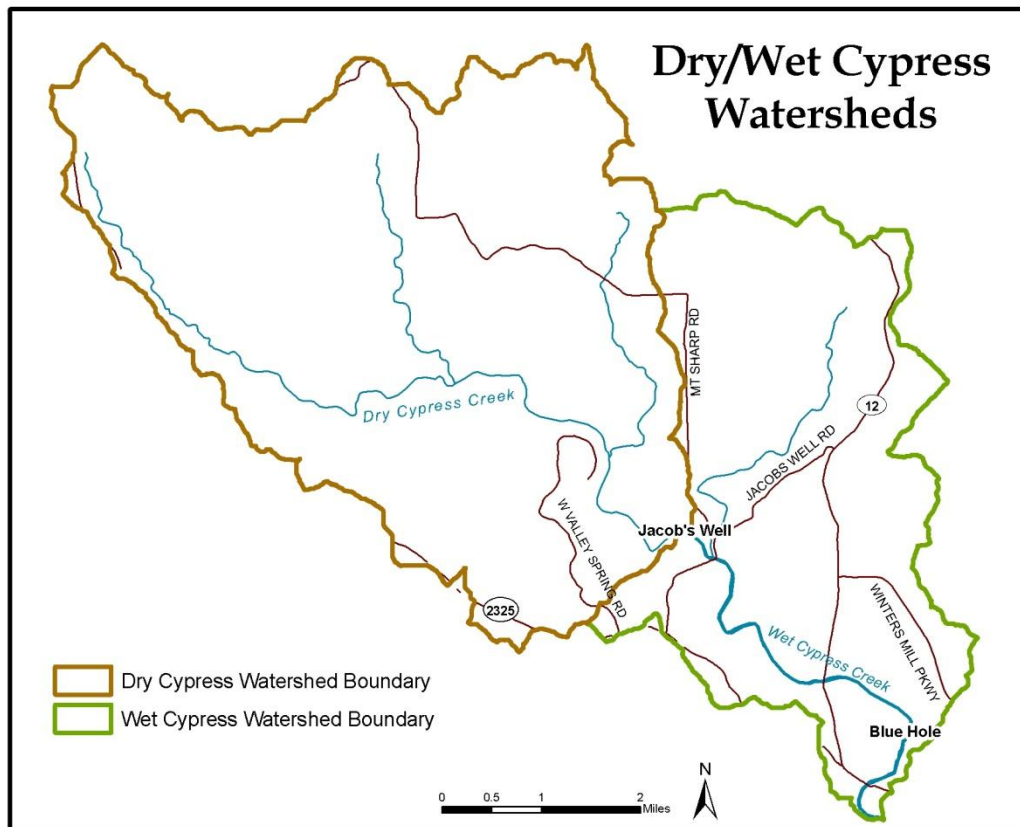
Figure 2.1. Dry and flowing segments of Cypress Creek.

Based on historic streamflows, Cypress Creek can be subdivided into dry and flowing segments (HTGCD, 2008). Unless a major rainfall takes place, the 9.5-mile segment above Jacob’s Well is usually dry (Figure 2.1). The spring at Jacob’s Well augments creek flows during the year for the downstream, 5.5-mile long stream segment trending southeast of Jacob’s Well. The downstream segment is referred to as Cypress Creek. The stream gradient of the lower part of the creek is calculated at 21.4 feet per mile.

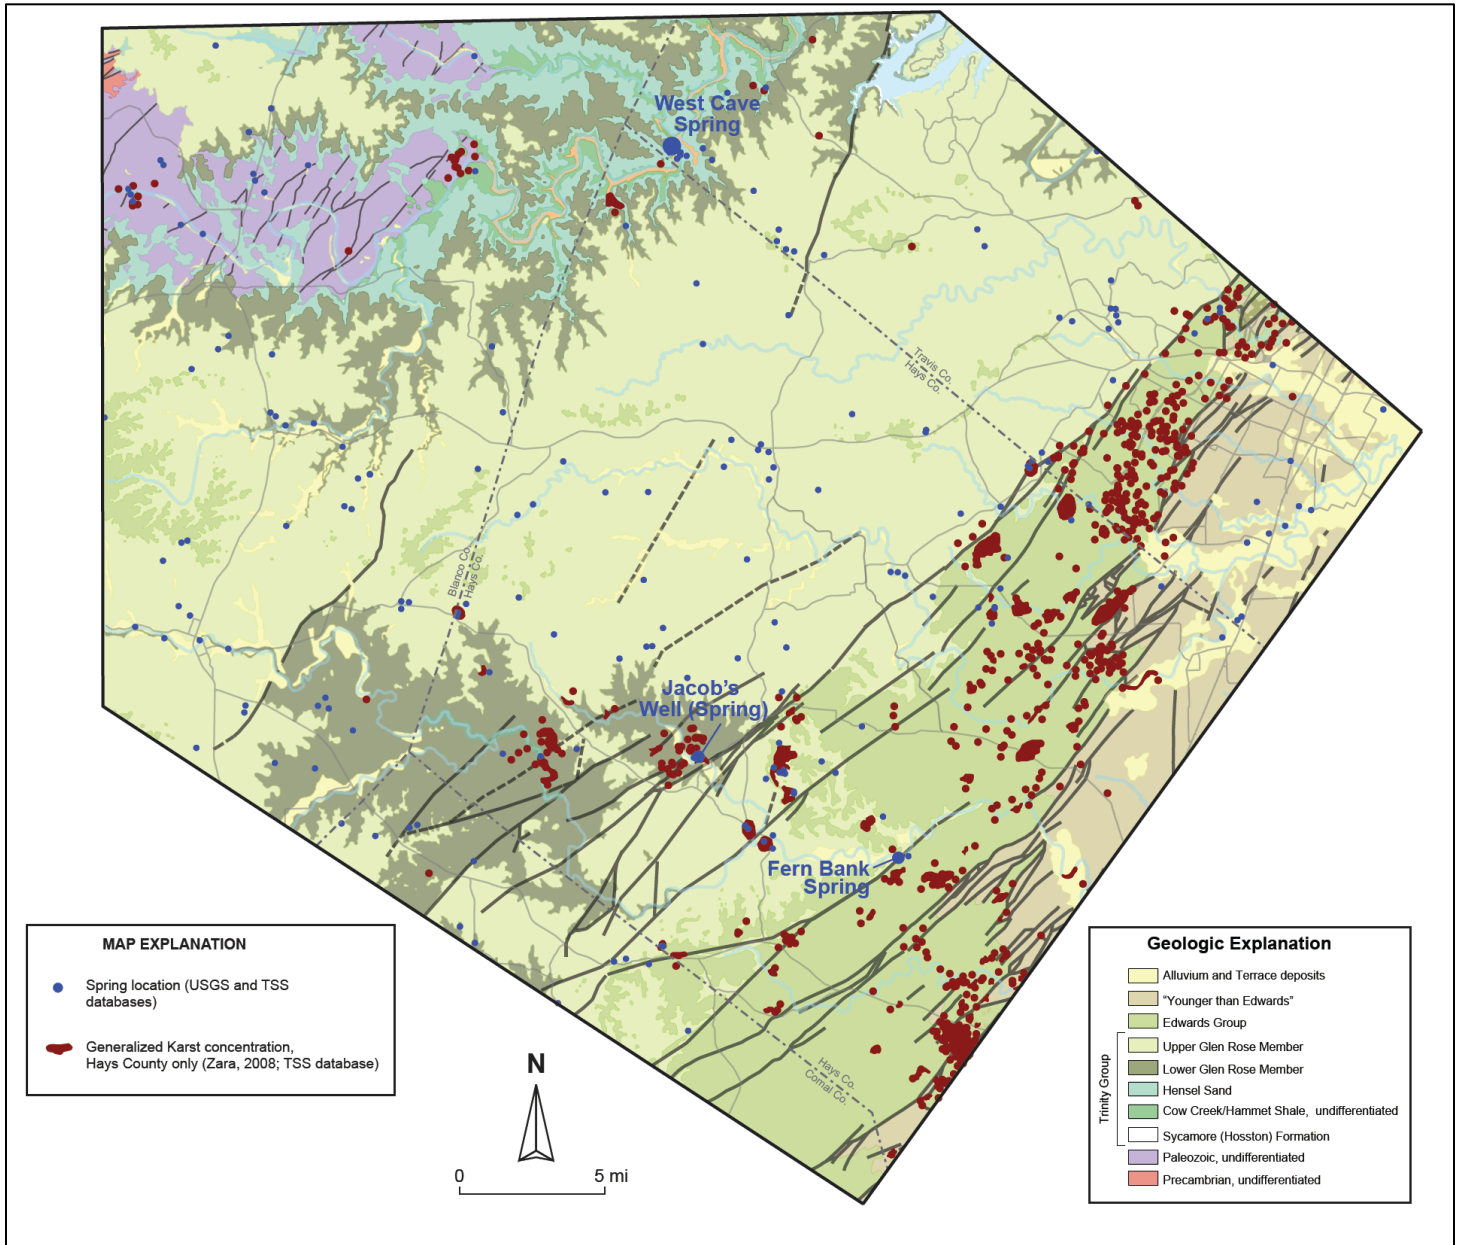
Figure 2.5. Generalized karst features, courtesy of HTGCD.

In the Cypress Creek watershed as in much of the Hill Country, karstic features are found throughout the landscape (Figure 2.5). Rounded limestone hills, cliffs and narrow valleys, springs and seeps are all part of this landform. Rock layers that alternate between easily eroded and hard rock form jagged cliff profiles and overhangs. The exposed limestone formation along Cypress Creek is a key karst feature that supports groundwater recharge to the underlying aquifer (HTGCD, 2008).

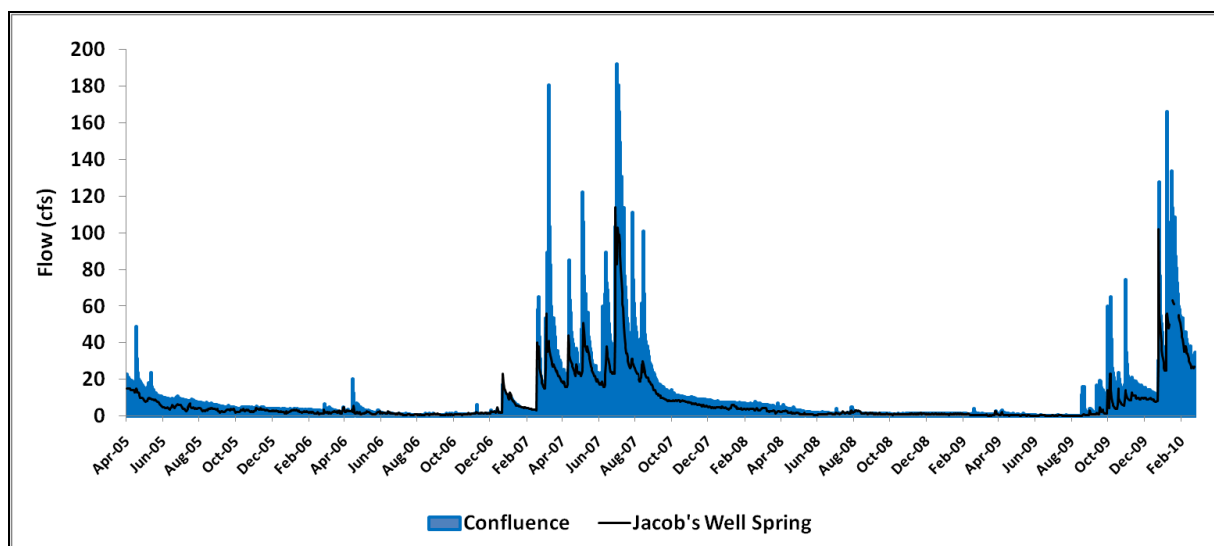
Figure 4.5. Flow estimated at the Cypress Creek confluence and recorded at Jacob's Well Spring (April 2005 – February 2010).

Flows estimated using the above method were compared to recorded instantaneous flows, and the resulting error ranged from -2.5% to 11.9%. This method was used to estimate historical daily mean flows for the Cypress Creek for January 2000 to February 2010. The resulting estimated flows are correlated very strongly with recorded spring flow at Jacob's Well starting in April 2005 (R^2 of linear regression = 0.86, $n = 1,745$; see Figure 4.5).

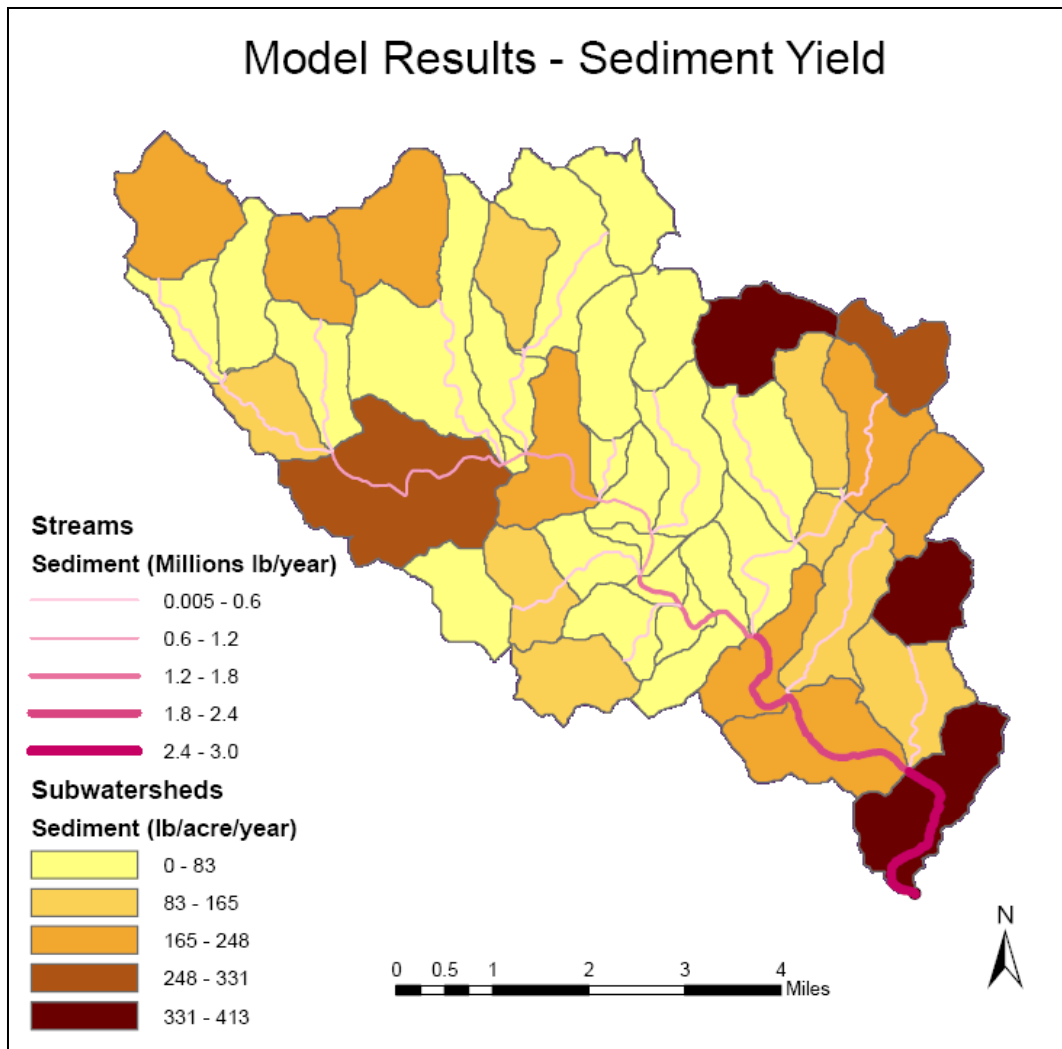
Figure 4.10. Simulated average sediment yield by subwatershed and reach, 2000-2009, using the SWAT hydrologic model.

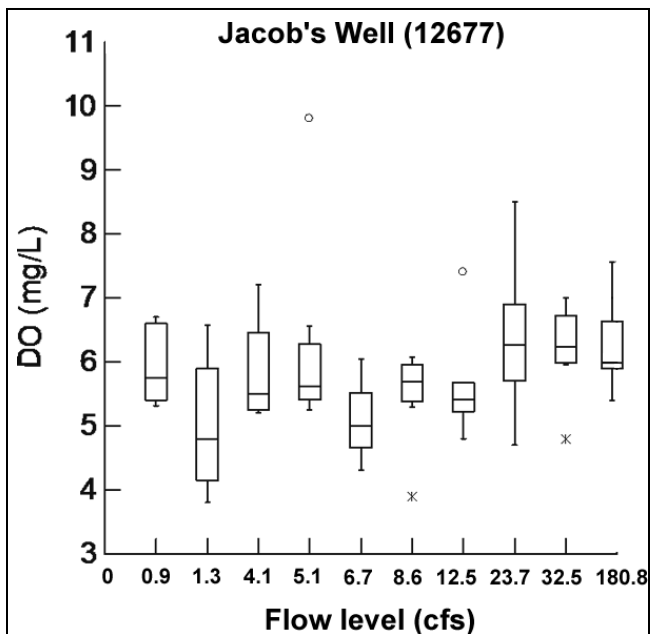
Flow levels (given in cubic feet per second) correspond to the 10th, 20th, 30th, etc. percentile of flows estimated at the Cypress Creek confluence, 2000-2009. In this chart, a flow level of 0.9 reflects DO concentrations measured when flow is ≤ 0.9 cfs, 1.3 indicates flow from 0.91 to 1.3 cfs, etc. At this site DO is more affected by the amount of groundwater flow coming out of Jacob's Well Spring than by streamflow at the surface.

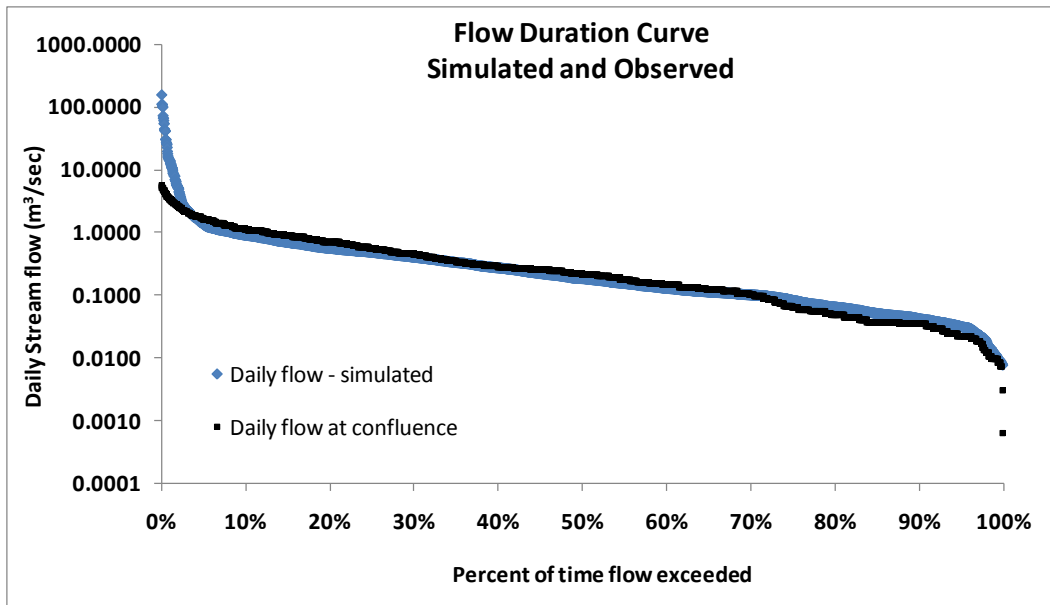
Figure B.1. Simulated and Observed Flow Duration Curves for the Cypress Creek watershed. Daily flows (m^3/sec) were simulated using the SWAT2000 hydrologic model.

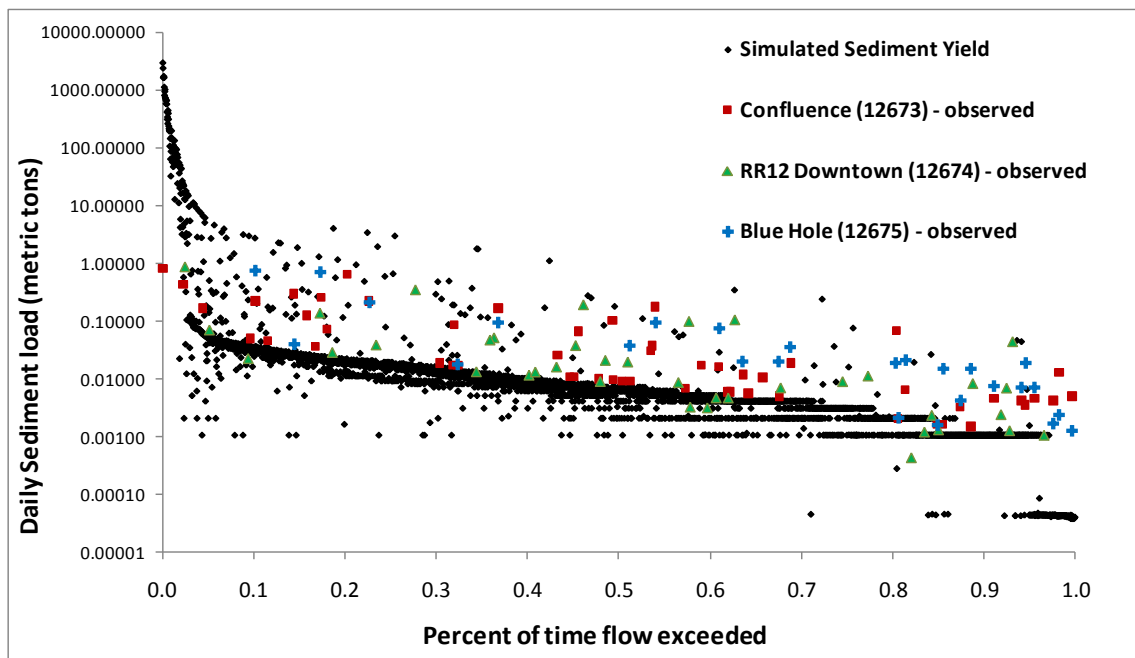
Figure B.2. Simulated and Observed Load Duration Curves for sediment (metric tons). Overall the simulated sediment loads are within the same range as observed, although at the lowest flows the model tends to underestimate sediment loads.
