Technical Memo 2018-0831

Dye Trace at Raccoon Cave near Jacob's Well Spring, Hays County, Texas

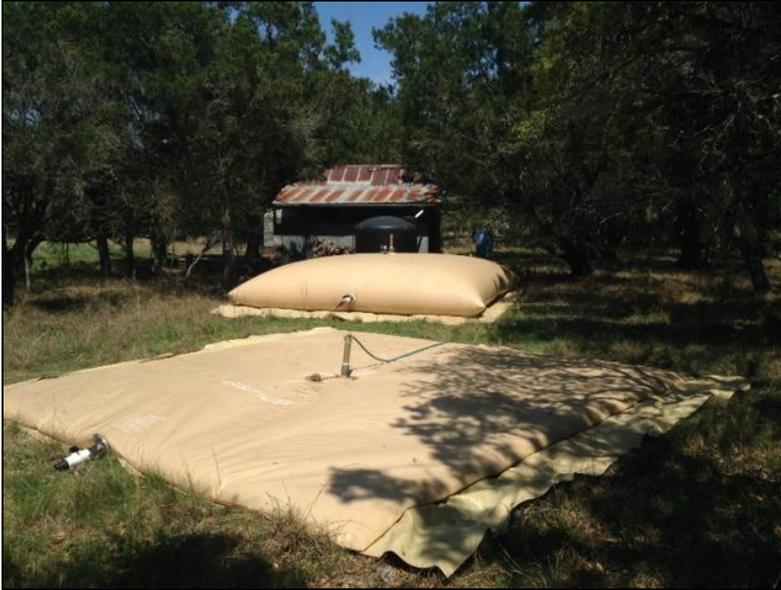
Bladder tanks for injecting water into Raccoon Cave. Each tank holds 5,000 gallons when full.

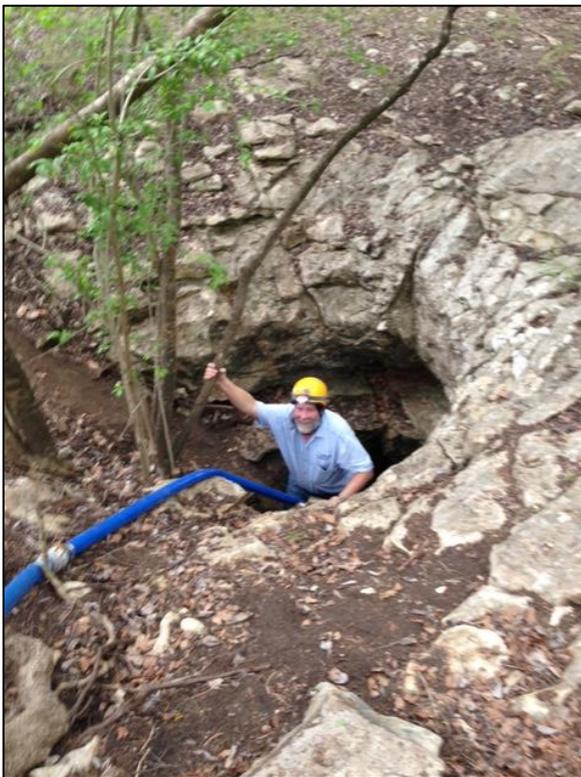
Entrance to Raccoon Cave showing injection hose going down to base of the cave. Brian Smith for scale.

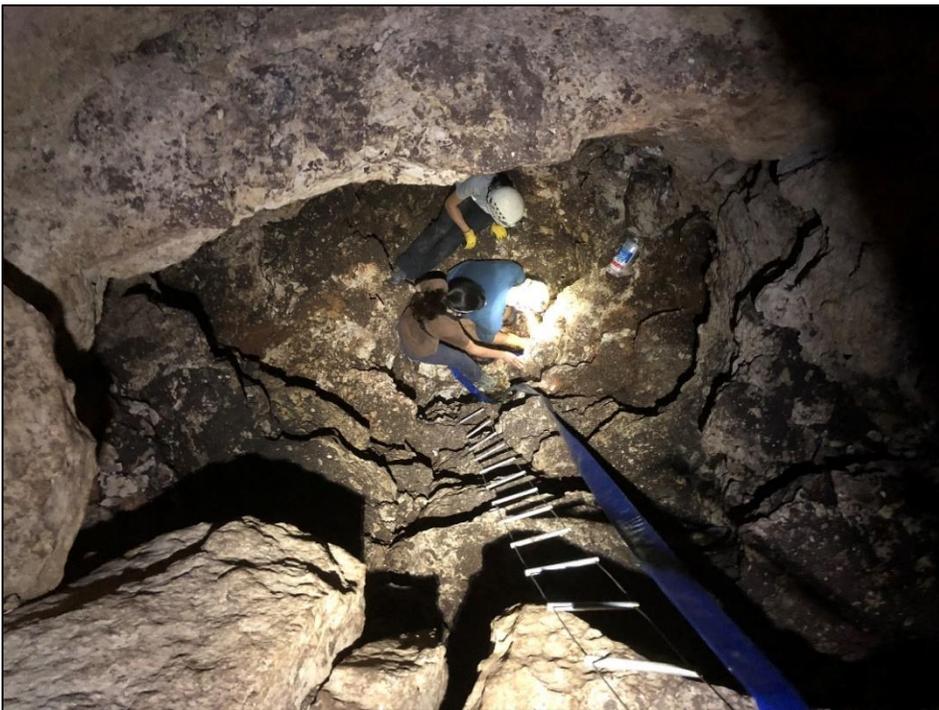
Photo looking down to base of shaft within Raccoon Cave showing the hose and injection of dye into the water flowing out of the hose.

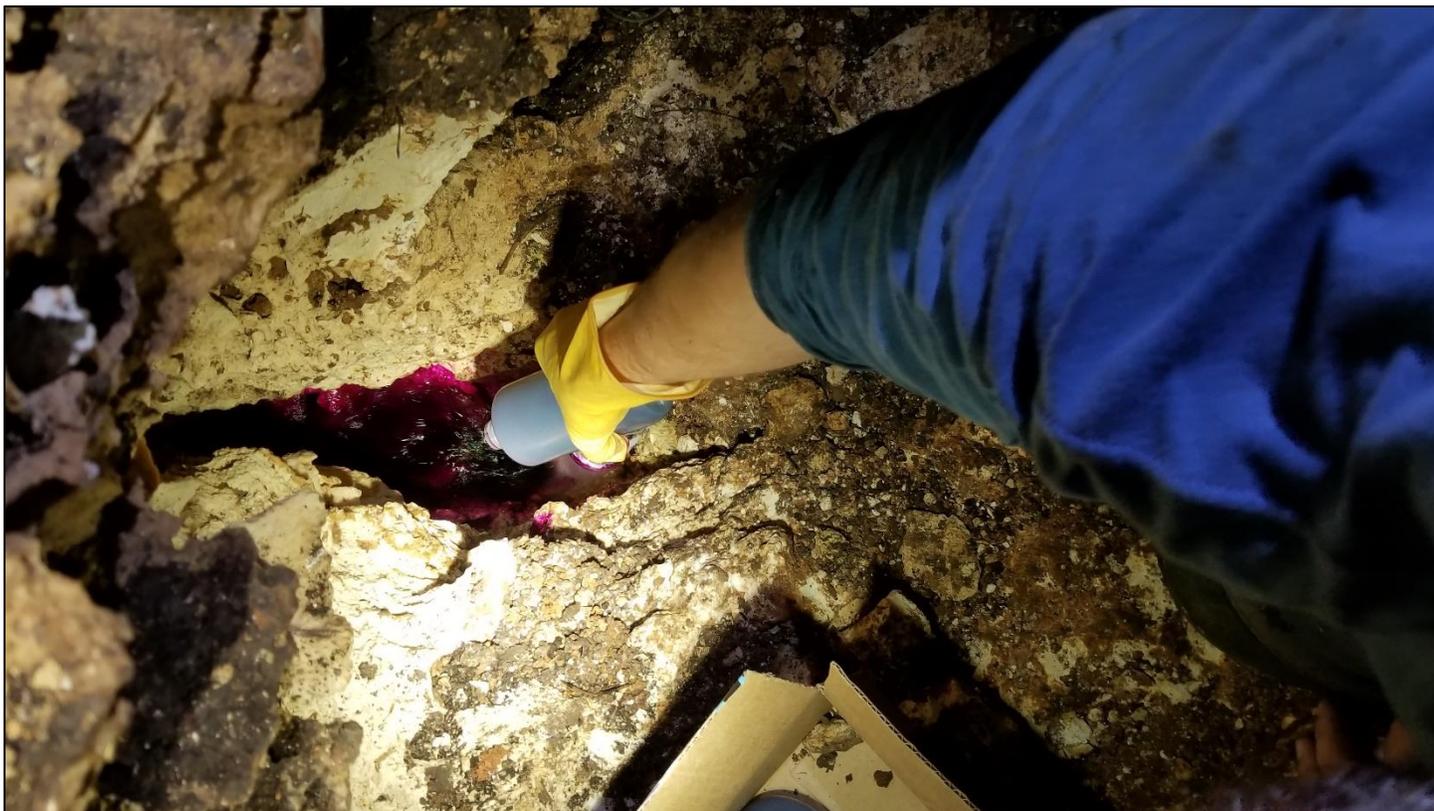
View of RWT dye as it is poured into the bottom of Raccoon Cave. Photo by Zara Environmental.

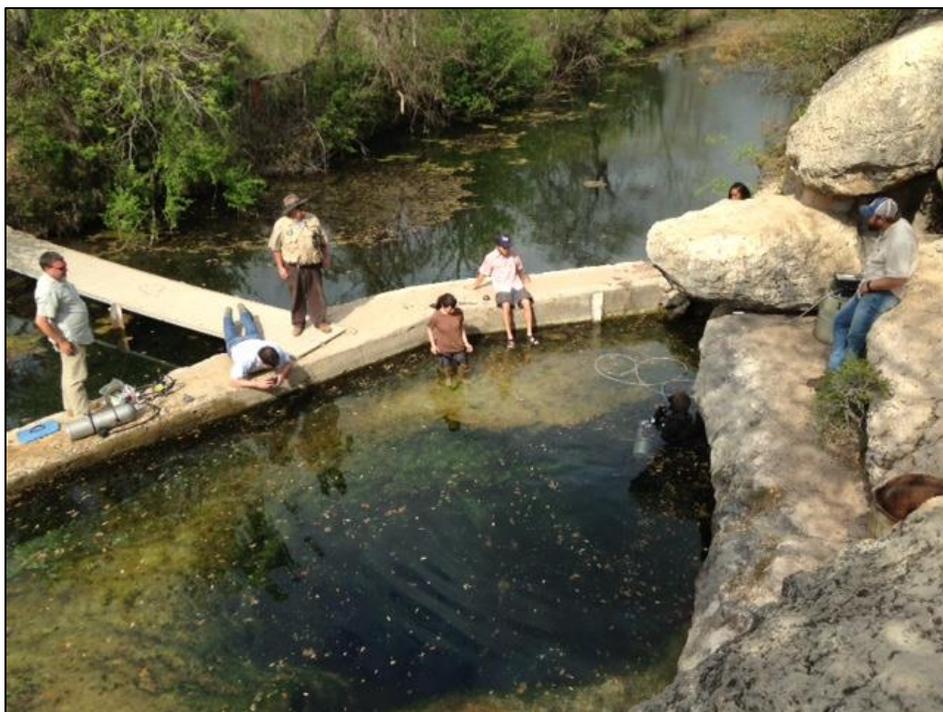
View of Jacob's Well Spring with the installation of the fluorimeter instrument by a diver (Greg Tatum). Also visible are the automatic sampler and tubing.

The in situ field fluorimeter manufactured by Eureka (Manta2) was deployed into JWS and secured to a bolt about 20 deep within the well. The instrument measured temperature, conductivity, turbidity, and fluorescence from RWT, fluorescein, and eosine. The minimum detection limit for the Manta2 fluorimeter (Cyclops 7F) is reported to be 0.01 ug/L (ppb) (<http://www.turnerdesigns.com/t2/doc/brochures/S-0209.pdf>).
